The X-Ray and the Button Battery

BY RURI LEE, MD, HIMANSHU PATEL, MD, & SHIVANI PATEL, MD

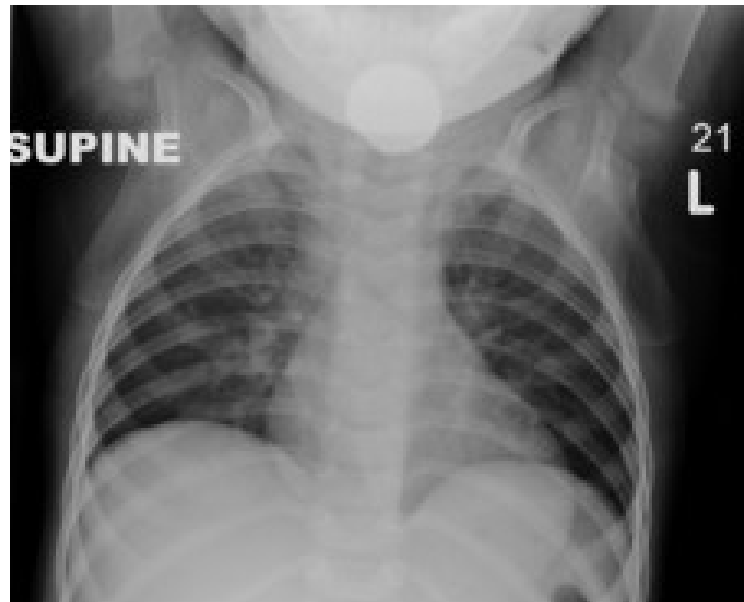
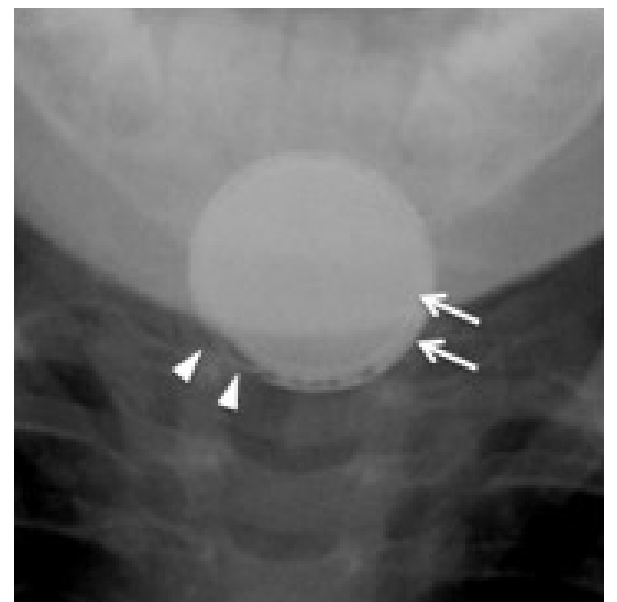
Frontal upright radiograph of the chest (left) shows a round metallic foreign object in the expected location of the proximal esophagus. Once magnified (right), the foreign body exhibits a double contour appearance (arrows). This corresponds to the shape of a button battery. Note regions of irregularity and lucency about the periphery of the button battery (arrowheads in 1b), which indicate corrosion of the battery itself.

It was reasonable to conclude based on the radiographic evidence of battery cell corrosion that significant esophageal injury had already occurred. An emergent laryngoscopy showed a full-thickness injury resulting in perforation of the posterior esophageal wall.

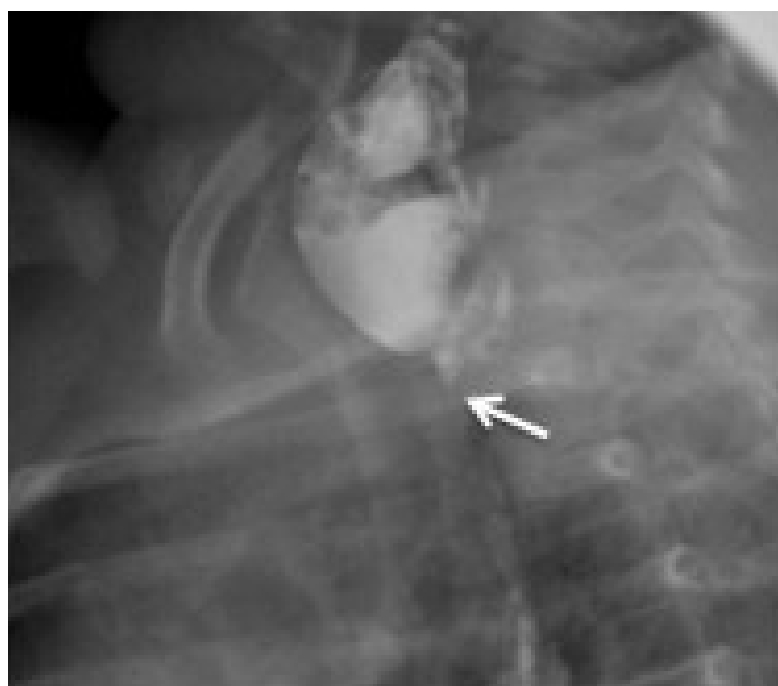
Spot image from an esophagram (left) shows focal narrowing in the proximal esophagus (arrow). Magnification of the level of narrowing (right) better delineates the abrupt tapering of the esophagus, indicative of a stricture at this level and dilation of the more proximal esophagus and hypopharynx secondary to downstream obstruction.
