## International Journal of Pediatric Otorhinolaryngology

## Review article

Pediatric button battery injuries: 2013 task force update<sup>☆</sup>

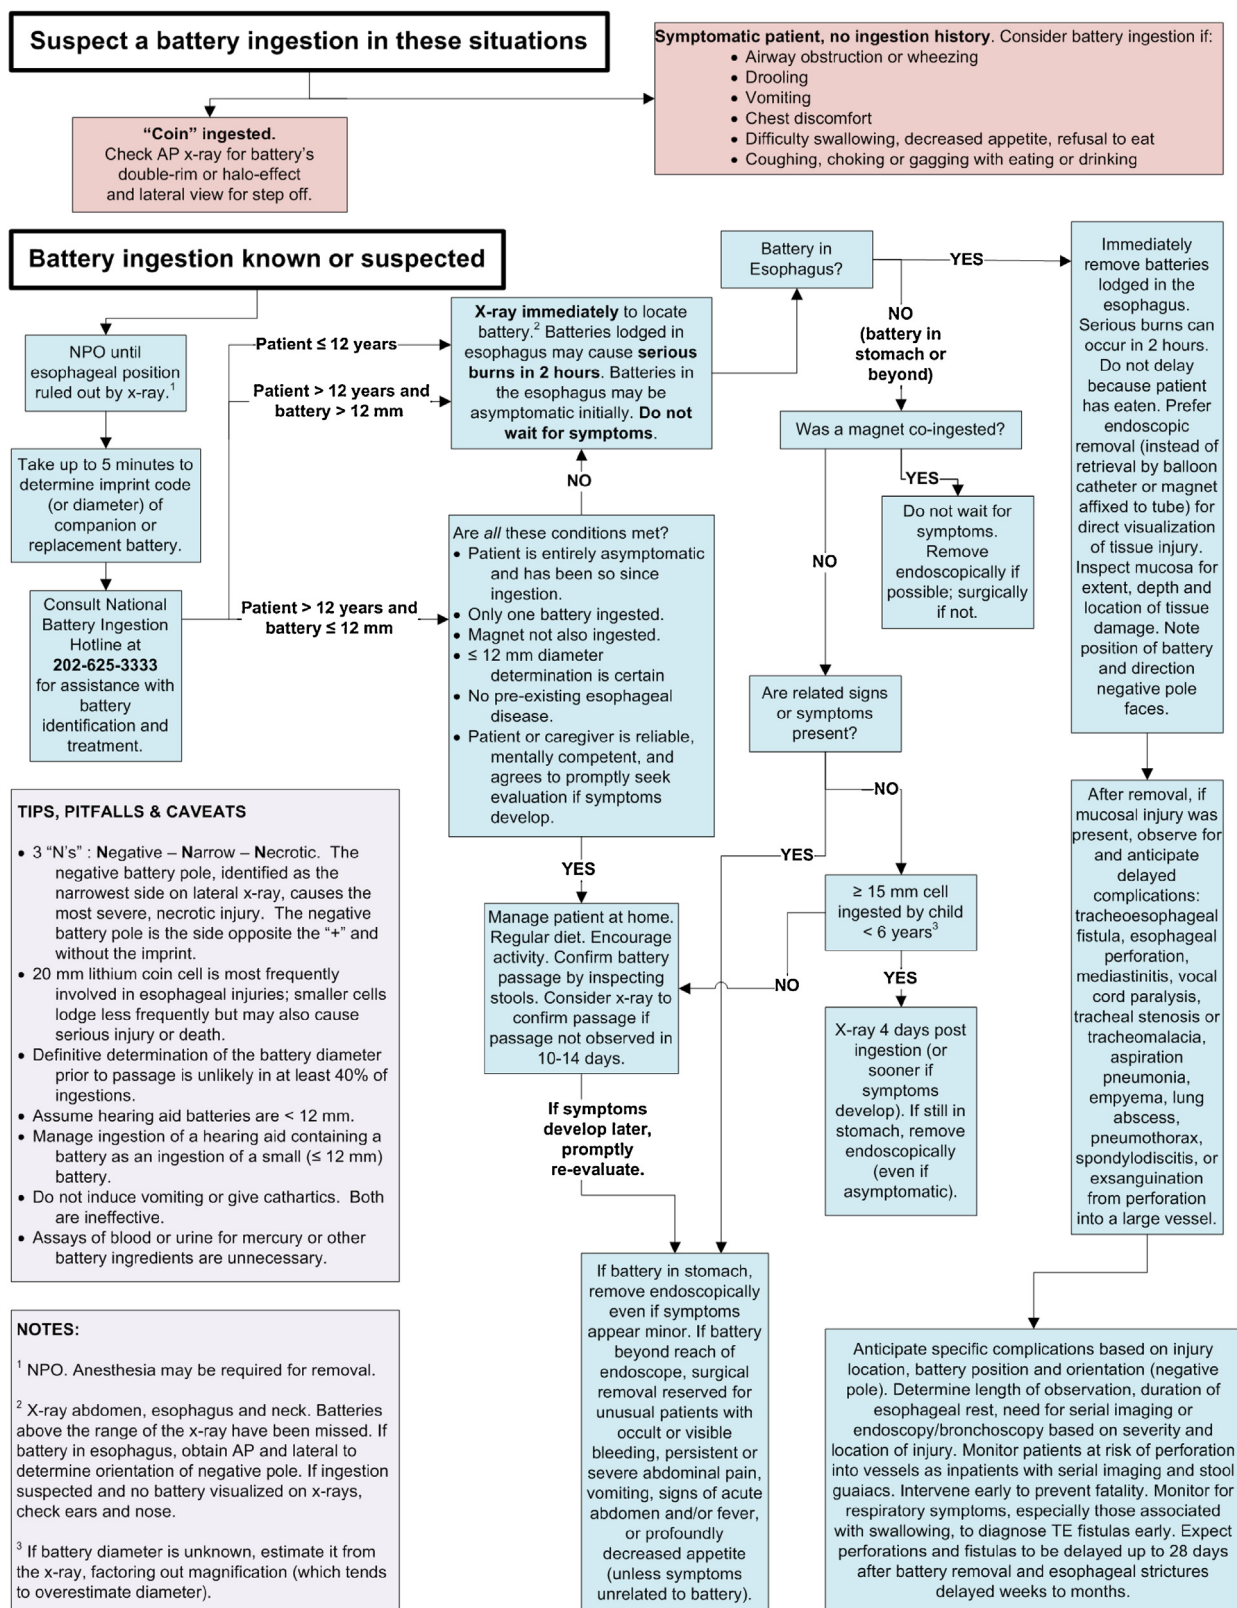
Fig. 1. NBIHTriage and Treatment Algorithm for Battery Ingestions. Reproduced with permission from [www.poison.org/battery/guideline.asp](http://www.poison.org/battery/guideline.asp) and adapted from: Litovitz et al. [4].

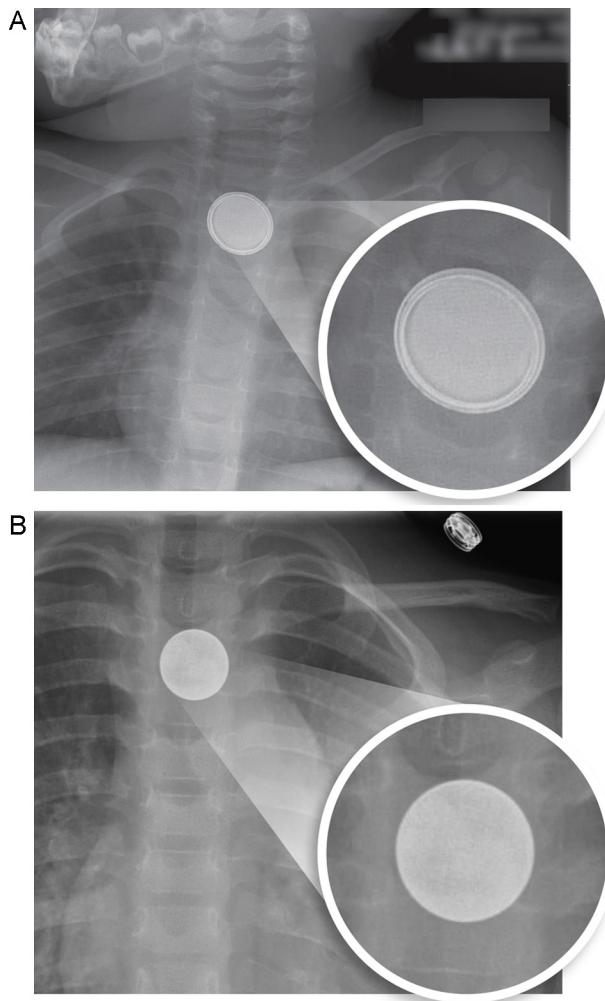
**Fig. 2.** Anterior-posterior X-rays. (A) On top, a button battery with *double ring or halo sign*; (B) On bottom, a coin with homogenous appearance. Reproduced with permission from Jatana [7].

X-ray imaging is essential to make the diagnosis of button battery ingestion and confirm the exact location in the body. When looking at any round, opaque foreign body on anterior–posterior X-ray, it is useful to *zoom in* and look for a *double ring* or *halo sign* to distinguish it from a coin (Fig. 2), [7]. The lateral X-ray can be helpful if a *step-off* can be noted, as seen with some batteries, however, there are some slimmer designed batteries on the market now that may not be distinguishable from a coin on a lateral image alone (Fig. 3). Close inspection of the imaging is important to quickly make the correct diagnosis. The negative or narrower

part of the battery can help guide clinicians to where the most severe tissue injury may occur and what potential complications should be considered in the patient. The 3 N's mnemonic, "Negative – Narrow – Necrotic", reminds the clinician where to anticipate the most severe damage.

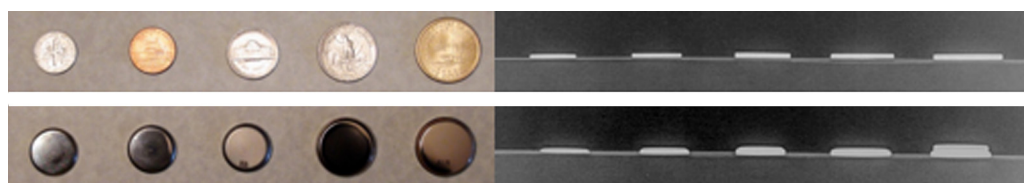
**Fig. 3.** Top row showing lateral X-ray imaging of the photographed coins; bottom row showing lateral X-ray imaging of the photographed button batteries. An obvious step-off CANNOT always be seen with all button batteries on lateral radiographic imaging (especially the 2 batteries on the far left).

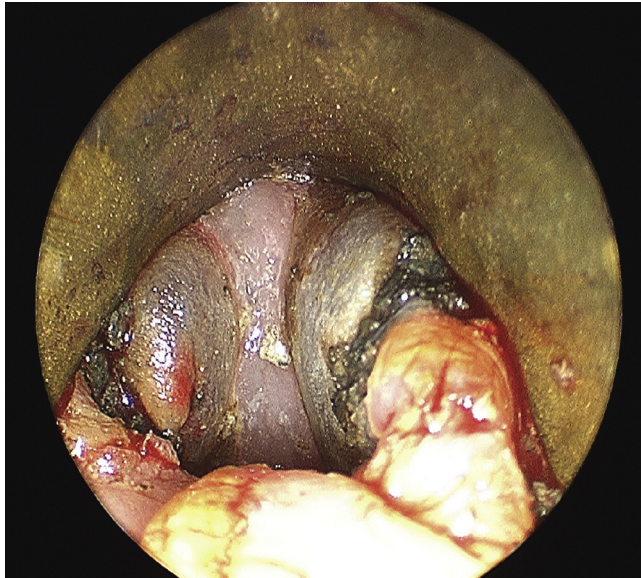
**Fig. 4.** Rigid esophagoscopy in a 4 y/o boy, visual inspection after removal of the battery can assess the extent of injury. Here the injury extended into the muscular layer of the esophagus. The negative pole was facing anteriorly, and the worse injury (tissue necrosis) is seen at the step-off of the negative pole. Direct laryngoscopy and bronchoscopy, flexible awake laryngoscopy, and esophagram were normal. Reproduced with permission from Jatana [7].

Assessment for the extent of acute injury should be performed, and the location and direction of the negative pole of battery allow the physician to anticipate the location of potential acute and delayed complications (Fig. 4). Airway evaluation with laryngoscopy and bronchoscopy in the operating room, even in absence of airway symptoms, should be considered to evaluate the membranous trachea, especially when the negative pole of the battery is facing anteriorly within the esophagus [7]. When the ingestion has occurred in the United States it is essential to report the case to the National Battery Ingestion Hotline (NBIH) at (202) 625-3333 with the size/type of battery, source of battery, and any available clinical data.

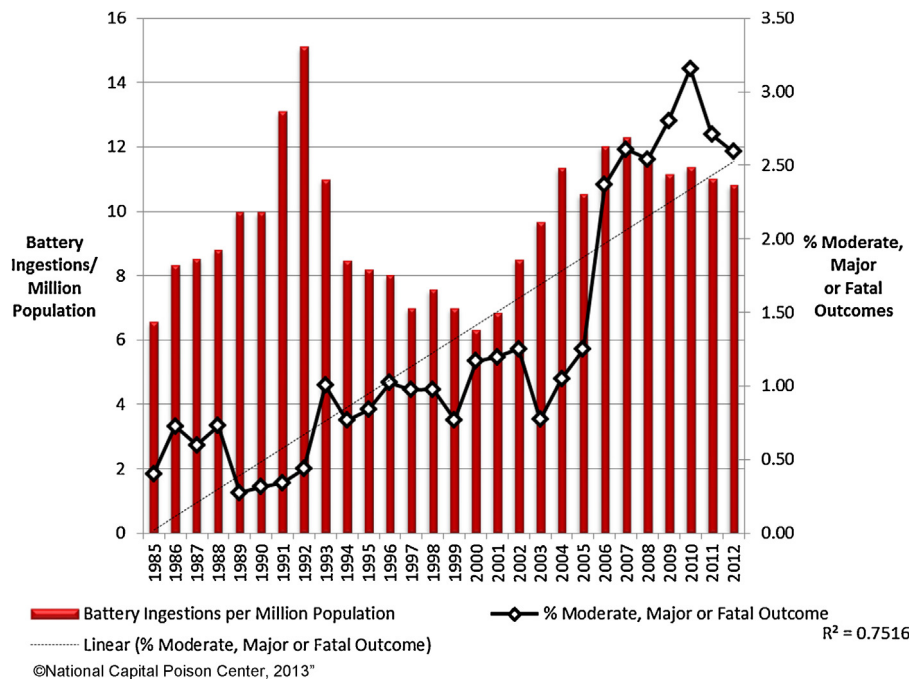
Fig. 5. National Poison Data System (NPDS) Button Battery Ingestion Frequency and Severity. Reproduced from [www.poison.org/battery/stats.asp](http://www.poison.org/battery/stats.asp), with permission [8].

Looking back, multiple data sources demonstrate a dramatic increase in the severity of button battery ingestions beginning around 2006, and the rate of major or fatal outcomes was more than 5-fold higher in 2006–2012 compared to the rate two decades prior (1986–1992). The National Poison Data System (NPDS), capturing data from all US poison centers, fails to show a consistent trend in battery ingestion frequency from 1985 to 2012, but displays a dramatic increase in cases with significant clinical outcomes over the past 7 years (Fig. 5). In 2012, 3435 button battery ingestions (10.8/million population) were reported to NPDS, but that is assumed to be just the tip of the iceberg, as most battery ingestions are not reported. Children younger than 6 years comprised 66% of button battery ingestions reported in 2012 [8], and all 30 of the fatalities reported to date have occurred in children 4 years of age or younger [9].

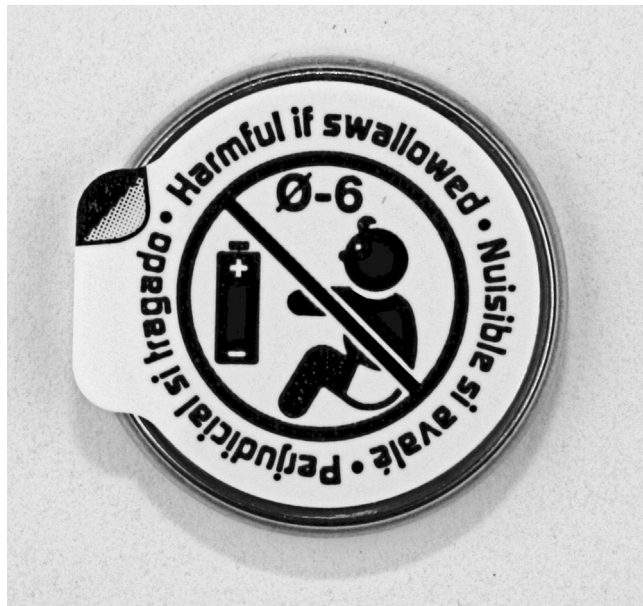
**Fig. 6.** A new warning label sticker on the negative pole of Energizer battery. The consumer has to manually remove this warning label and this should increase awareness of the hazard.

Energizer has already introduced new child-resistant packaging that meets U.S. Consumer Product Safety Commission guidelines. This packaging is made from more durable and flexible materials and includes the improved warning copy and safety pictogram. Also, in the absence of a satisfactory battery solution, removal of a warning label sticker covering the negative pole is necessary for the battery to work in a device and should help educate the consumer regarding the need for proper battery handling safety and disposal (Fig. 6). The sticker does not protect against potential injury if battery is ingested with sticker still attached.

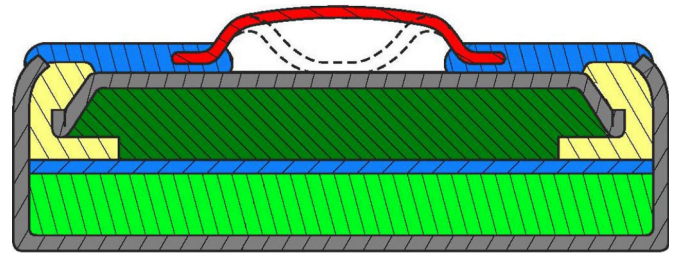
**Fig. 7.** Proposed modification to the button battery to prevent injury from occurring when not in a device. A switch which flips down to connect circuit is only active when within a compatible device compartment. Developed by Tim Cassidy, Best Buy, Inc.

In addition, there are technical challenges and problems still to overcome with regard to button battery redesign, to completely eliminate the hazard. Not all compartments connect the circuit at the same point. A battery that cannot 'connect the circuit' inside the body, without requiring any change in battery compartment design will be the answer. One such design by Tim Cassidy of Best Buy<sup>®</sup>, Inc., as shown in Fig. 7 consists of soft metal plate which

when pressed down will make contact with the anode and complete the circuit [11]. In the normal position the battery is not active. One limitation to this is backward compatibility of electronic devices, as the battery compartment circuit must connect in this specific location. Alternative battery designs that mitigate or eliminate the hazard, while altogether avoiding the backward compatibility issue are also being considered.
